CONNECTICUT RIVER BASIN  
LEBANON, NEW HAMPSHIRE

**MASCOMA LAKE DAM**  
**NH 00153**

**PHASE I INSPECTION REPORT**  
**NATIONAL DAM INSPECTION PROGRAM**

**MAY 1979**

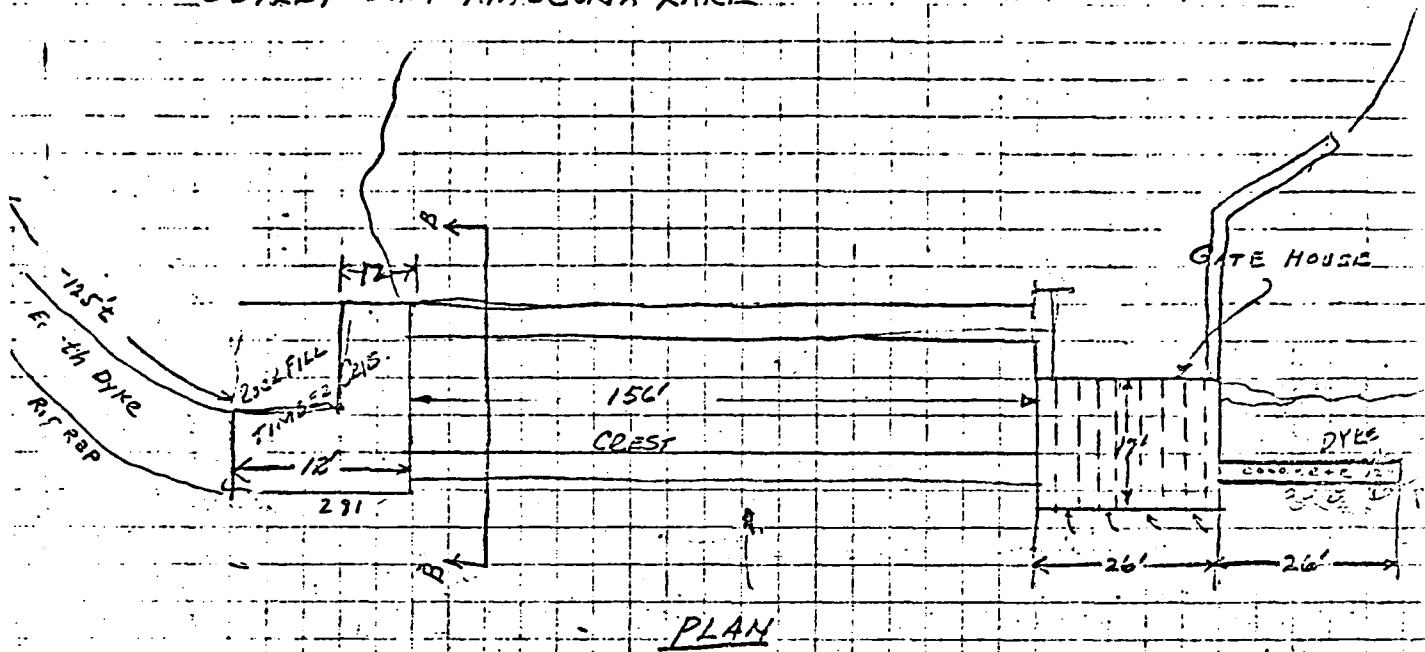
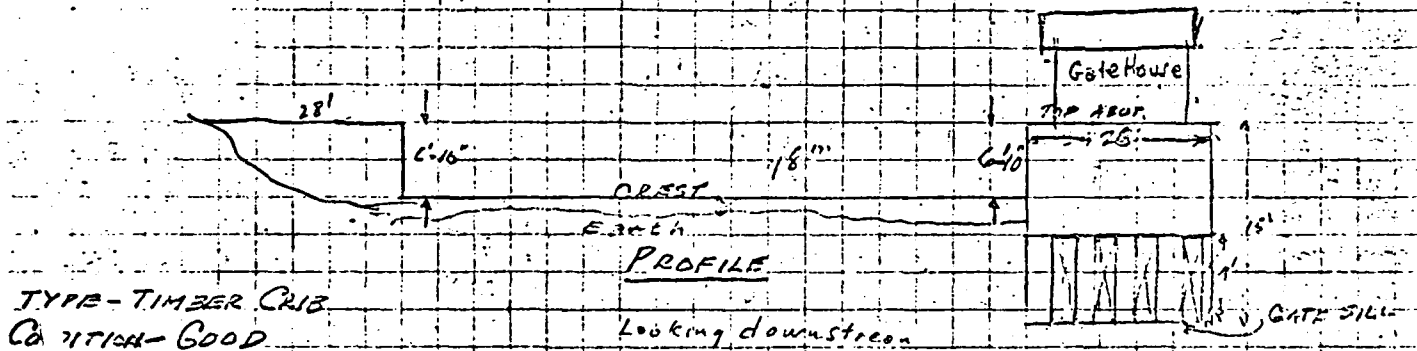
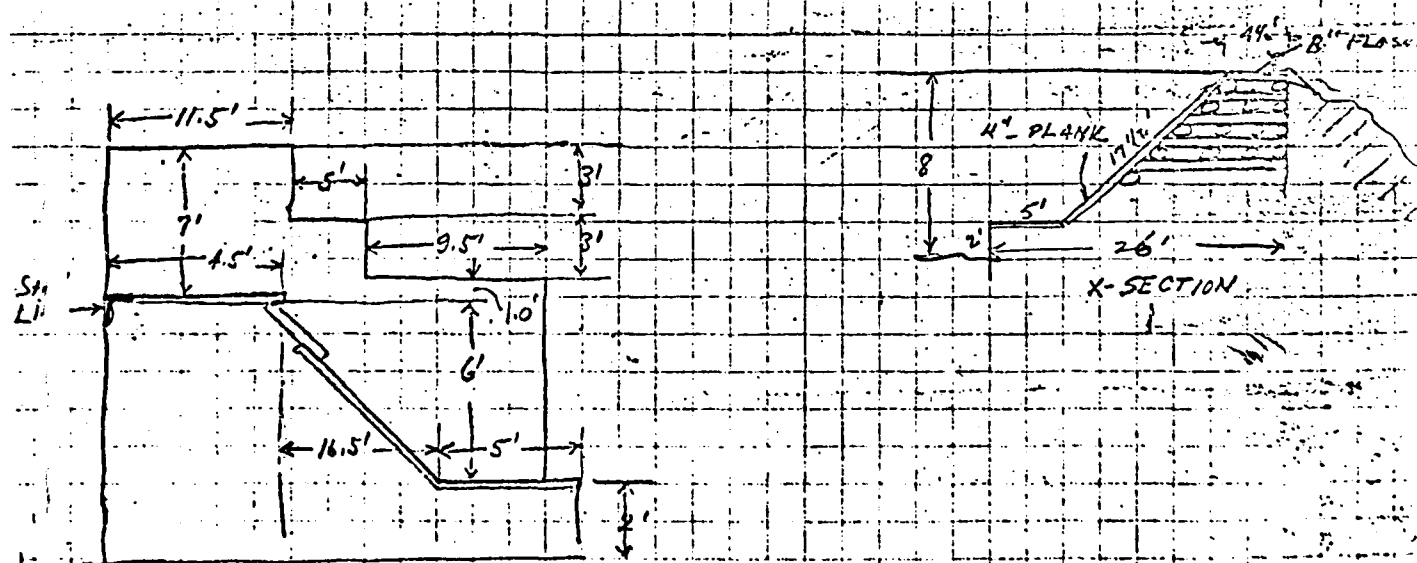
PHOTO #11-#12

Based on visual inspection, the dam is judged to be in fair condition. The soil adjacent to the northwest corner of the gate house has settled. The lower 6 feet of the northern wing wall on the downstream side have settled 6 inches and apparently tilted. The wooden planks on the flashboard section were observed to be in poor condition. Continuance of this classification depends on proper operations and maintenance of the dam.

The concrete of the gate house wingwalls is in poor condition. Joint alignment is generally good, but both horizontal and vertical cracks were observed. No cavitation was noted but several areas of spalling were observed. The bottom 6 feet of the northern wingwall on the downstream side has settled 6 inches and apparently has tilted. Water is flowing behind the wingwall and eroding the adjacent soil. Observations indicated that the fill behind the lower 6 feet of the wingwall consisted of boulders. The slope above this wingwall has been protected with a thin layer of lean concrete (Photographs No. 11 and 12, Appendix C).

Within one year after receipt of this Phase I report, the New Hampshire Water Resources Board should implement the remedial measures resulting from studies made to determine the cause of settlement and movement of the lower portion of the northern wingwall on the downstream side.
